Manhole Inspection Summary

Manhole # S31EE1020MH

Inspection ☐ Is Incomplete Rating: **3) Fair**

Location Address: **3811 CANTERBURY RD**

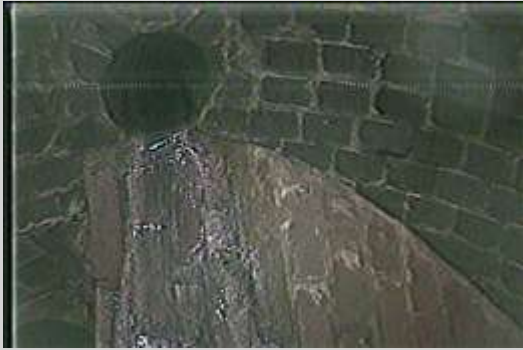
8 in. Circular Gravity Sewer

Pipe Material: **Clay** ☐ Pipe Lined

Invert Depth: **14.90** (ft.) Flow Characteristics: **Fast**

Infiltration: **None**

Pipe Seal Cond: **Unknown**

Connects To: **House connection / Service line**

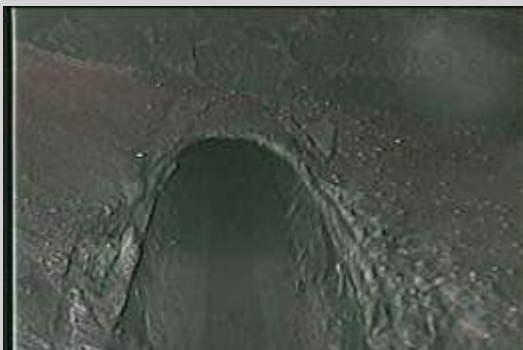
8 in. Circular Gravity Sewer

Pipe Material: **Clay** ☐ Pipe Lined

Infiltration: **None**
